Lake Kitchawan Wastewater Study

November 15, 2021

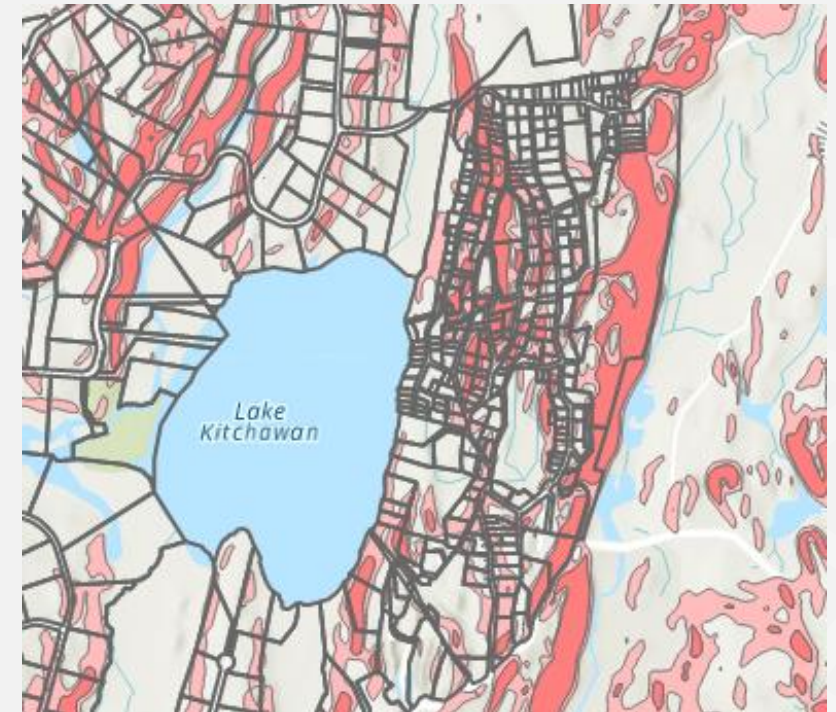
Project Area Steep Slopes

High percentage of steep slopes

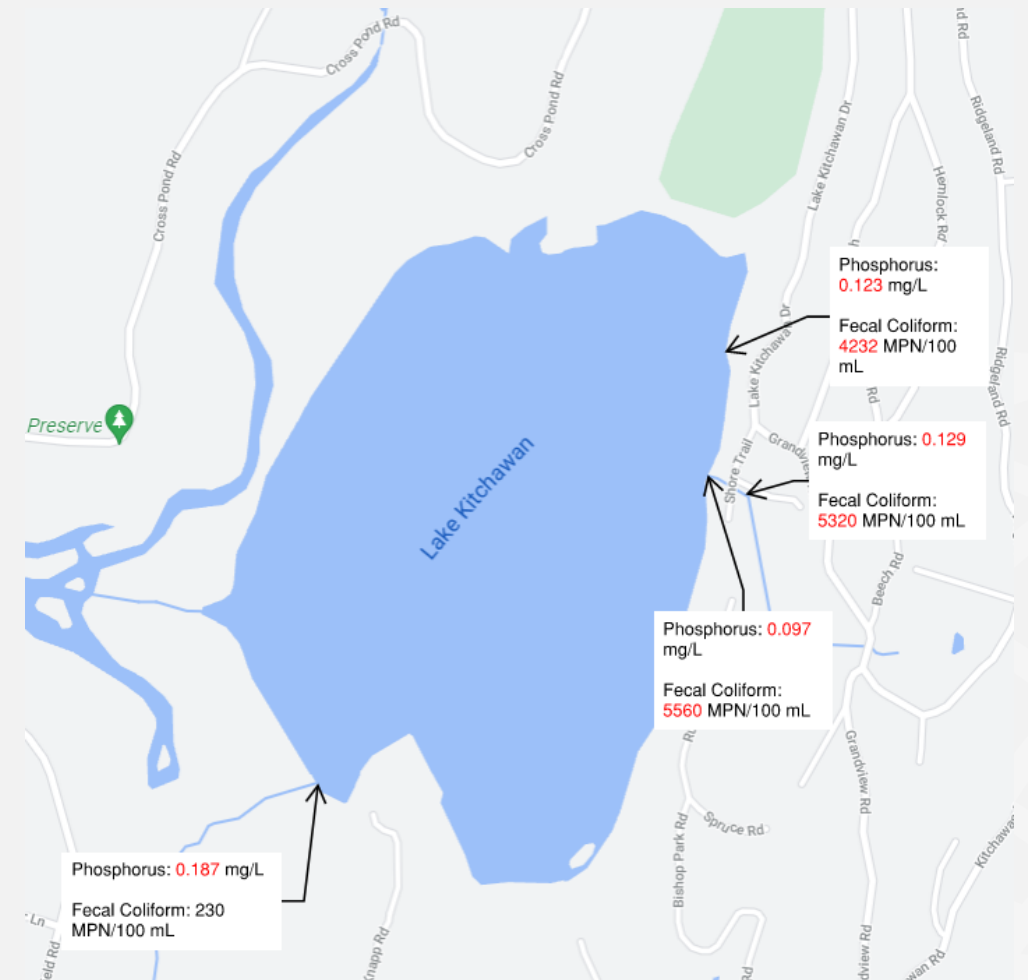
2021 Average Concentrations

- Catch Basins:
 - All 3 exceeded had elevated fecal coliform and E. coli levels
- Lake Samples:

Hazard Level:		Phosphorus (mg/L)	Fecal Coliform (MPN/100 mL)
		Eutrophic conditions when > 0.020 mg/L	Health hazard by NYSDOH above 1,000 col/100 mL
Outfall at Private Beach	Average	0.123	4,232
	Max	0.260	16,000
Outfall on Shore Trail	Average	0.097	5,560
	Max	0.240	16,000
Stream on Shore Trail	Average	0.129	5,320
	Max	0.280	9,200
Stream on Pound Ridge Side	Average	0.187	230
	Max	0.290	230
